Attachment A:

Summary and Recommendations on Issues of Additional Investigation at the Landsburg Mine site in Ravensdale

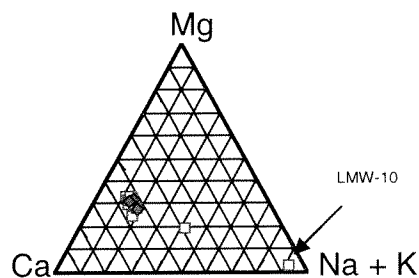
Data for the above graph was taken from the May 2004 groundwater analytical results. LMW-10 was a recently installed deep well. At present, we cannot preclude the high Na and K to be artifacts of the well installation process (from bentonite seal or from material in Portland cement used to fill the borehole beneath the well screen). Coupled with an upward hydraulic gradient at the discharge (portal) areas, this points to a complex flow system with upward groundwater flow from deeper levels. If there is contaminated water at these deep levels, based on the results of LMW-10, it may be expected that deeper waters may reach the shallow levels that affect groundwater use and surface water quality. Therefore, there is a need to identify the water quality emanating from the deeper region of the former mine.

If the groundwater sampled at deep well LMW-10 taps the flow path of older, Na dominant water that may exist at deeper levels in the mine, this implies that there is still little known about the nature of groundwater quality that emanates from the deeper portions of the mine. Although this deeper, older type of groundwater was not identified in the Landsburg mine in the 1996 RI/FS, the recent results from LMW-10 is the first indication that such older water exists. The deep well(s) will intercept these potential deep flow paths and monitor contaminants deriving from a deeper source in the former mine.

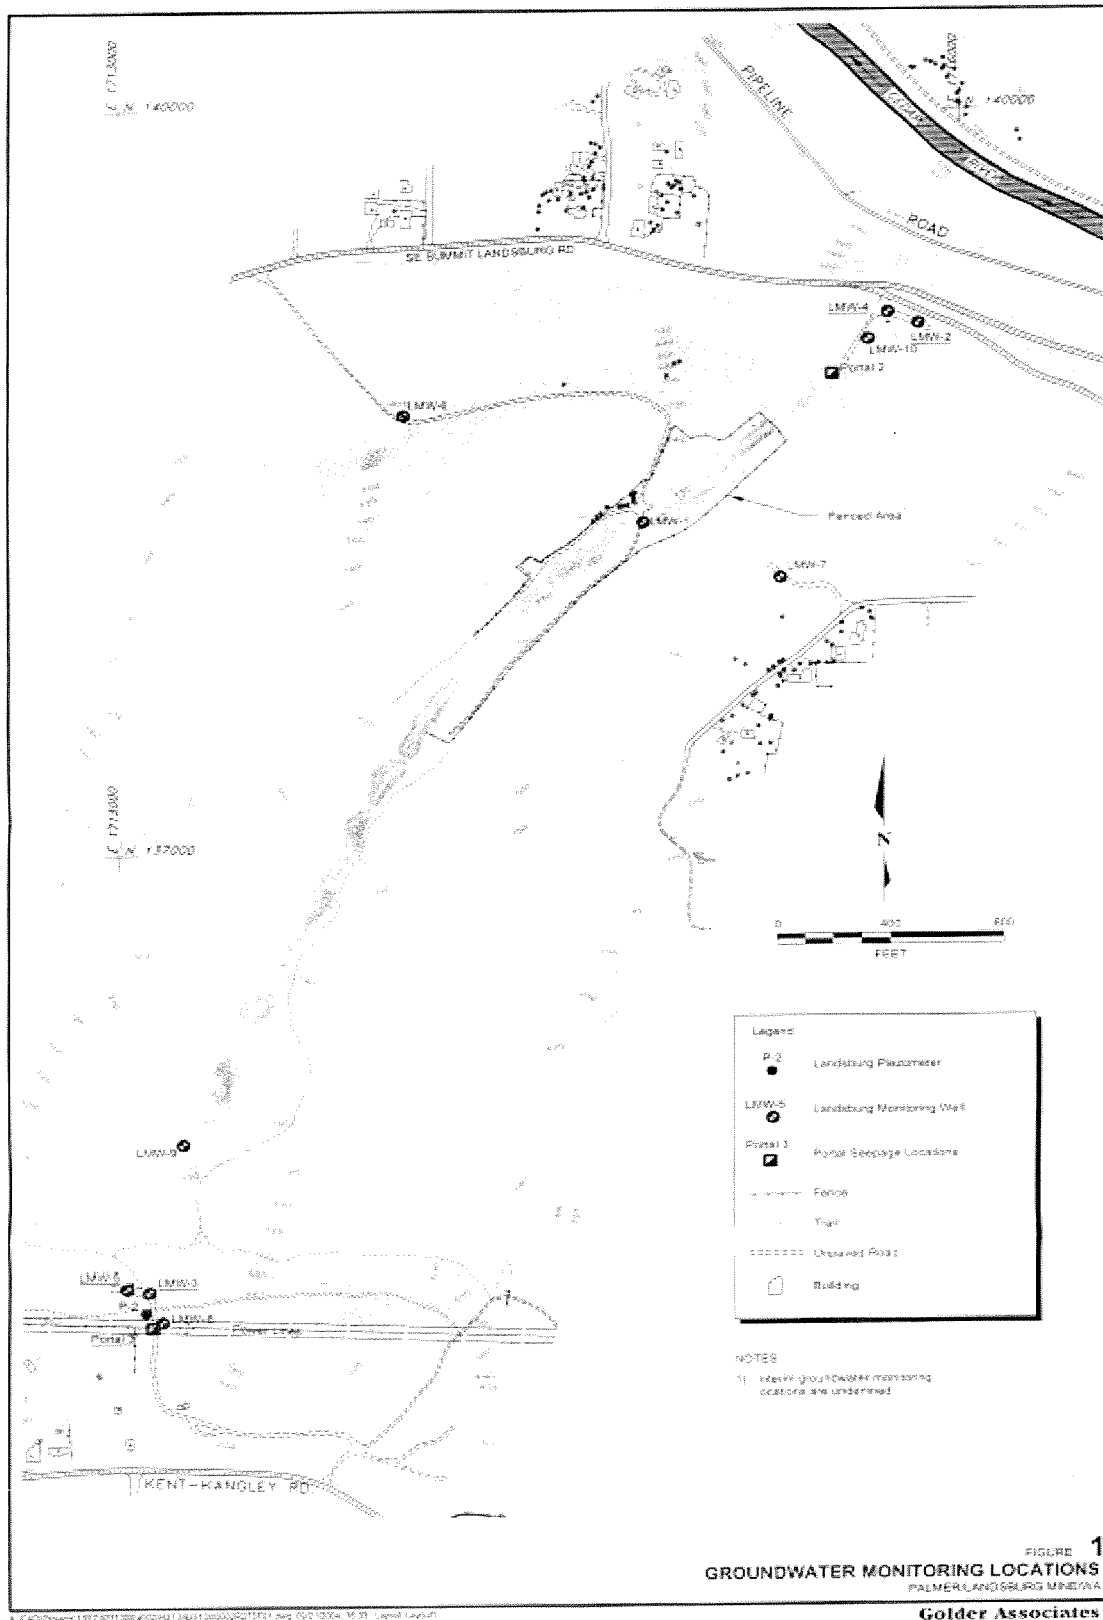
May 2000: Wells sampled were LMW-2, LMW-4, LMW-3, LMW-5, and Rogers Portal #3 seep water (see Figure 1 map). Results showed no significant change from 1996 Report of Investigation. Total dissolved solids, iron and manganese were the only compounds detected in excess of screening levels which are secondary maximum contaminant levels (SCMLs). SCMLs are not health based standards, but are based on aesthetic qualities of water. The high iron and manganese concentrations appear to be typical of coal mining regions.
